**Schedule B Municipal Class Environmental Assessment for a New
Treated Water Storage Facility in Madoc, Ontario (FINAL)**

Madoc Elevated Tank Video
Inspection (Authorized Inspection
Services Inc., 2019)

ROV INSPECTION REPORT

Plant : Madoc elevated concrete water tower

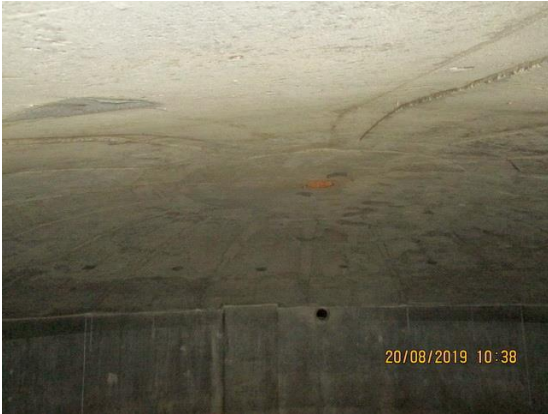
Underside of roof, vent and overflow opening

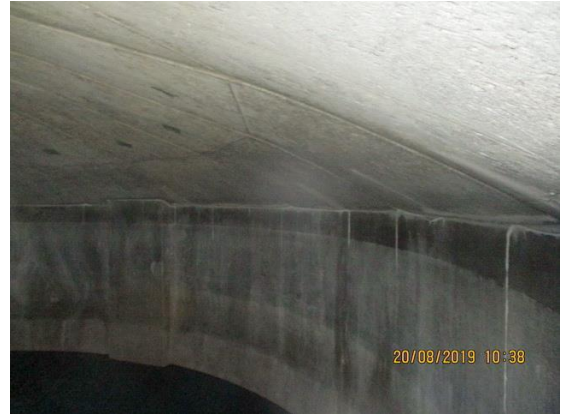
Look right from hatchway at roof-wall interface

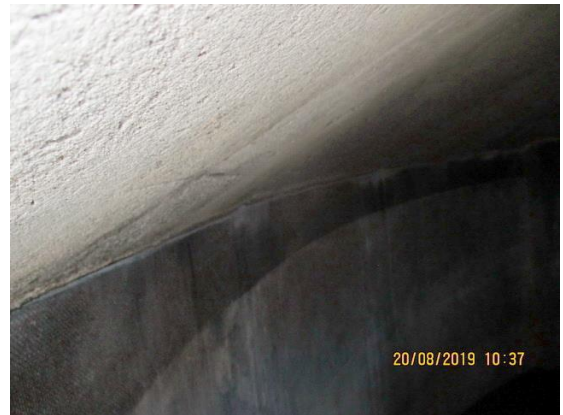
Look left from hatchway at roof-wall interface

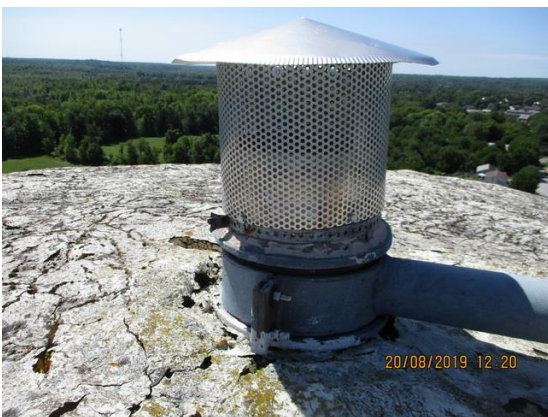
- 3.5 The screened vent located at the peak of the domed roof appears in good condition. A structural lifting assembly located on the roof top is clamped and bolted to the roof vent nozzle. The topside roof hatchway is intact and was locked after inspection completed.

Roof vent appears intact and in good condition

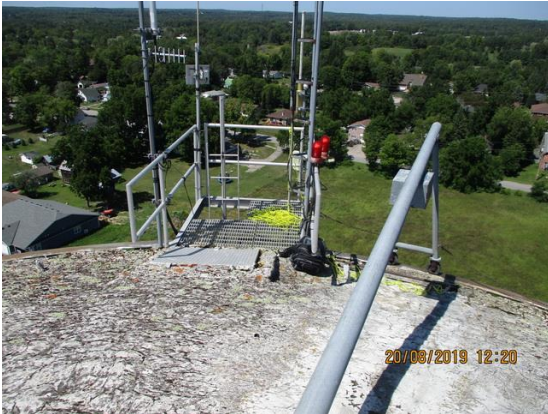
View top side landing and hoisting structure

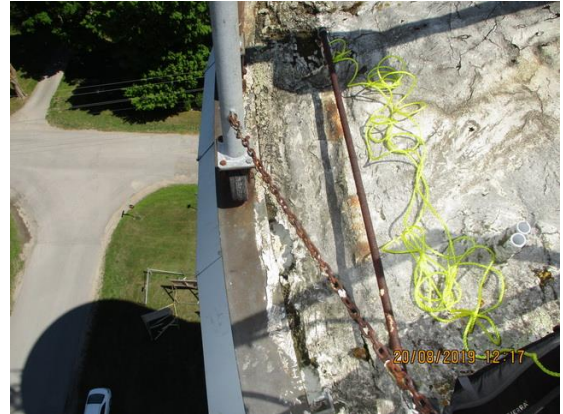
- 3.6 The tank roof has some areas of damaged insulation, as noted in previous inspections. Areas of insulation sheet metal, underside of the tank to tower transition, are corroded.

Tank roof edge near ladder; some insulation damage

- 4.1 OCWA personnel to review the inspection video and this report.
- 4.2 Rearrange the communication cable running down the front of the vertical external ladder to allow a fall-arrest slider to be used in future climbs up the tower.
- 4.3 Request from AIS NDE information on other services relating to, for example: cleaning, further inspection and any required repairs.
- 4.4 Plan to drain and enter the elevated tank for cleaning during 2020 or when practical and take the opportunity, at that time, to perform further inspections on the inlet-outlet pipe.
- 4.5 Continue to monitor the sheet metal on the external under-edge of the elevated tank insulation which was found to be corroded. Plan to repair/replace in future.
- 4.6 Plan to assess and perform repairs on the tank roof insulation, where damaged or missing.

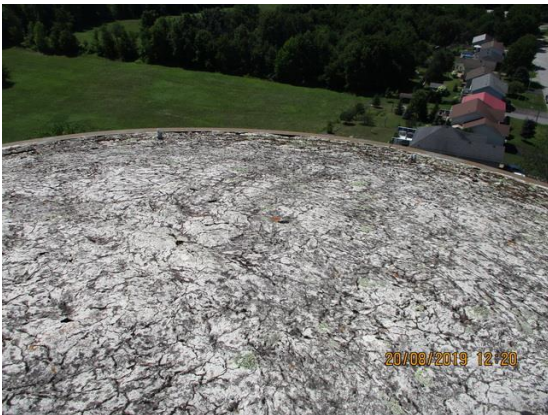
Section of tank roof topside insulation

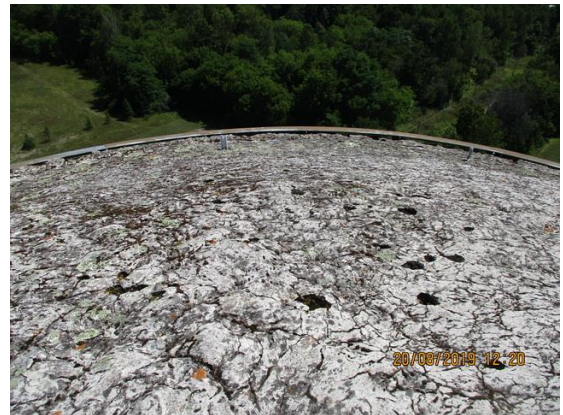
Tank roof section; some areas of insulation damage

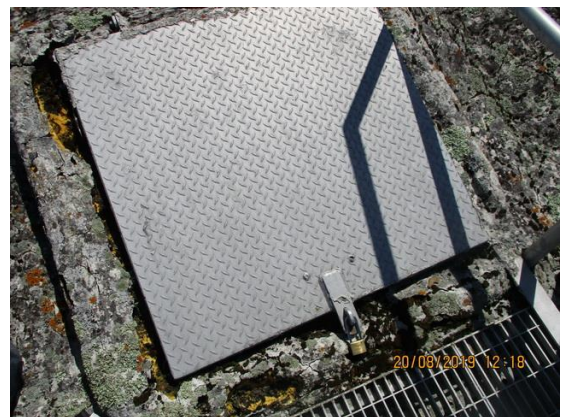
Roof hatch secured with a new lock after survey

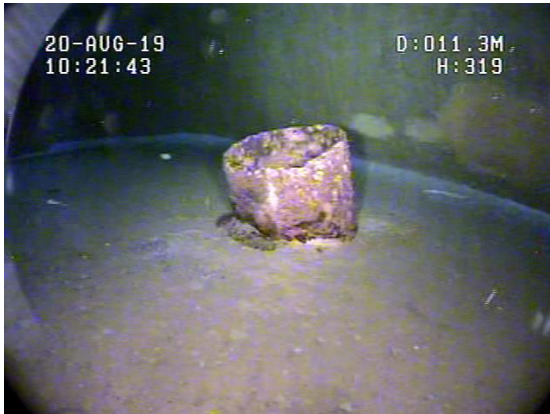
- 3.1 The inlet-outlet carbon steel pipe portion which penetrates up through the elevated water tank floor appears to be corroded with heavy scale and deposits seen.

10:19:00	Good view of Styrofoam pieces which have been floating on surface for years
10:20:30	Moving down a section of tank wall to bottom
10:21:30	View of inlet-outlet pipe on tank bottom which has heavy scale and deposits

Inlet-outlet pipe appears corroded

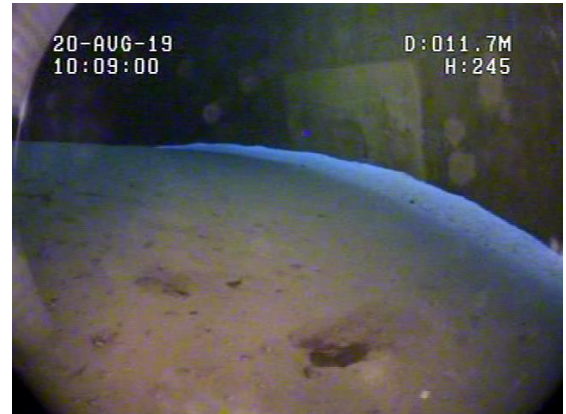
- 3.2 Sediment, small bits of debris and material with a powdery concrete appearance is seen across the upwardly convex floor of the tank. Styrofoam sections, as in previous surveys, seen floating on the surface.

Wide view of convex tank floor and sediment

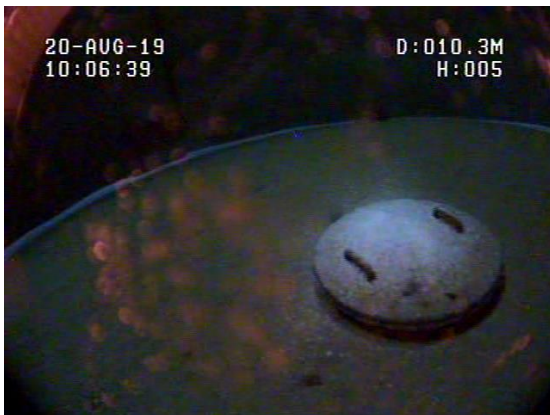
Floor centre access hatch appears intact

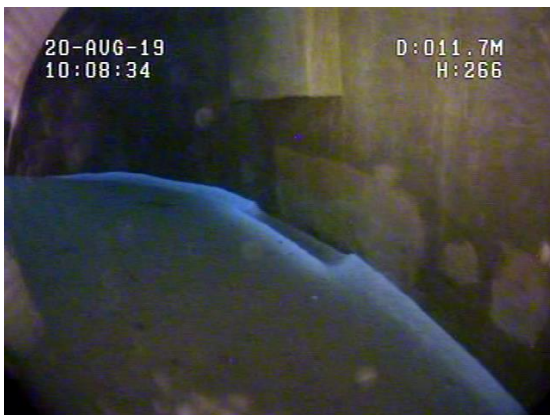
Outer floor sediment with white, powdery appearance

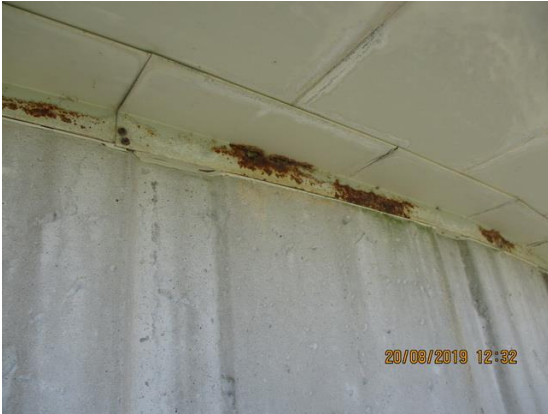
Underside of tank edge insulation sheet metal corroded

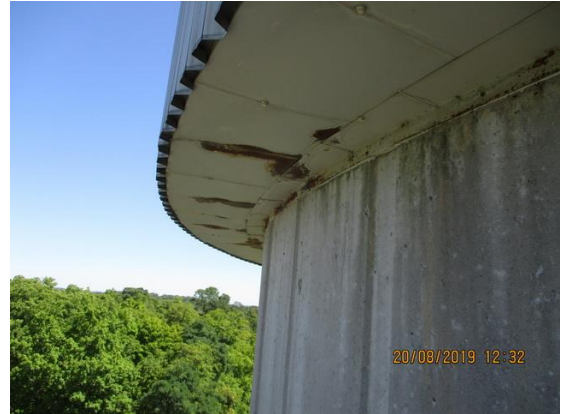
Sheet metal joints stained under tank edge

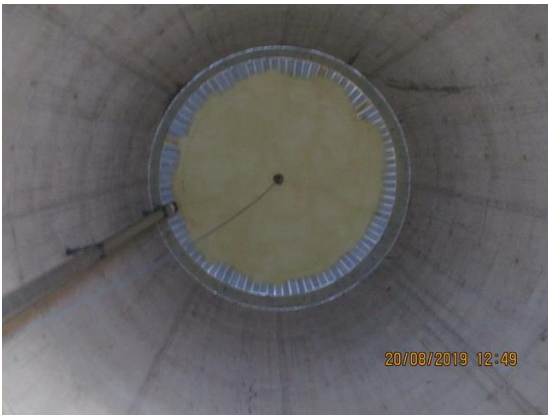
- 3.7 The underside of the tank floor, viewed from ground level, appears in good condition.
- 3.8 The external tower ladder appears intact although installed cable interferes with usage of a harness fall-arrest slider. A double lanyard system was used to climb the tower.

Underside of elevated tank viewed straight up

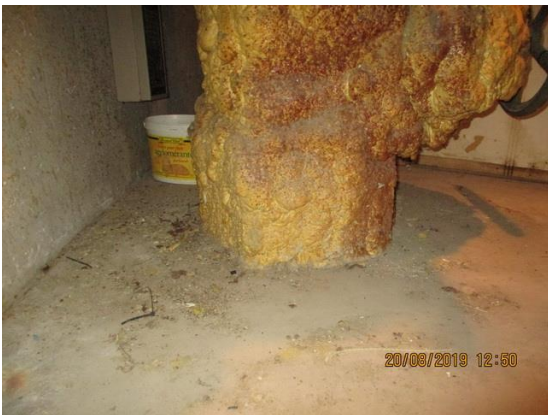
Floor-piping interface at grade level – no leaks seen

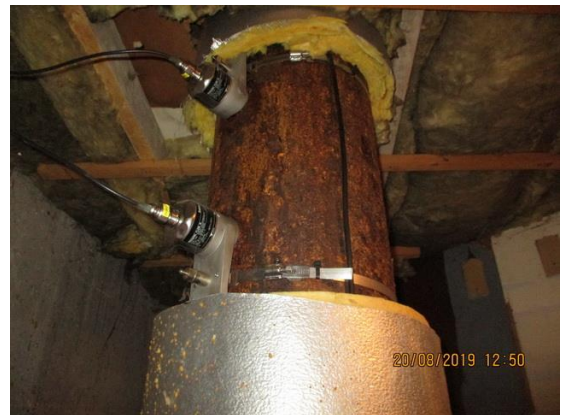
Bare section of outlet-inlet piping
